State of Michigan Part 201 and Waste Disposal System Database Information

**LETTER REPORT
MDOT BOVINE YARD SITE
BOVINE, BARAGA COUNTY, MICHIGAN**

TDD No.:	S05-0107-008
Date Prepared:	November 2, 2001
Contract No.:	68-W-00-129
Prepared by:	Tetra Tech EM Inc.
START Project Manager:	Bradley C. White
Telephone No.:	(312) 946-6464
U.S. EPA On-Scene Coordinator:	Michelle Jaster
Telephone No.:	(734) 692-7683

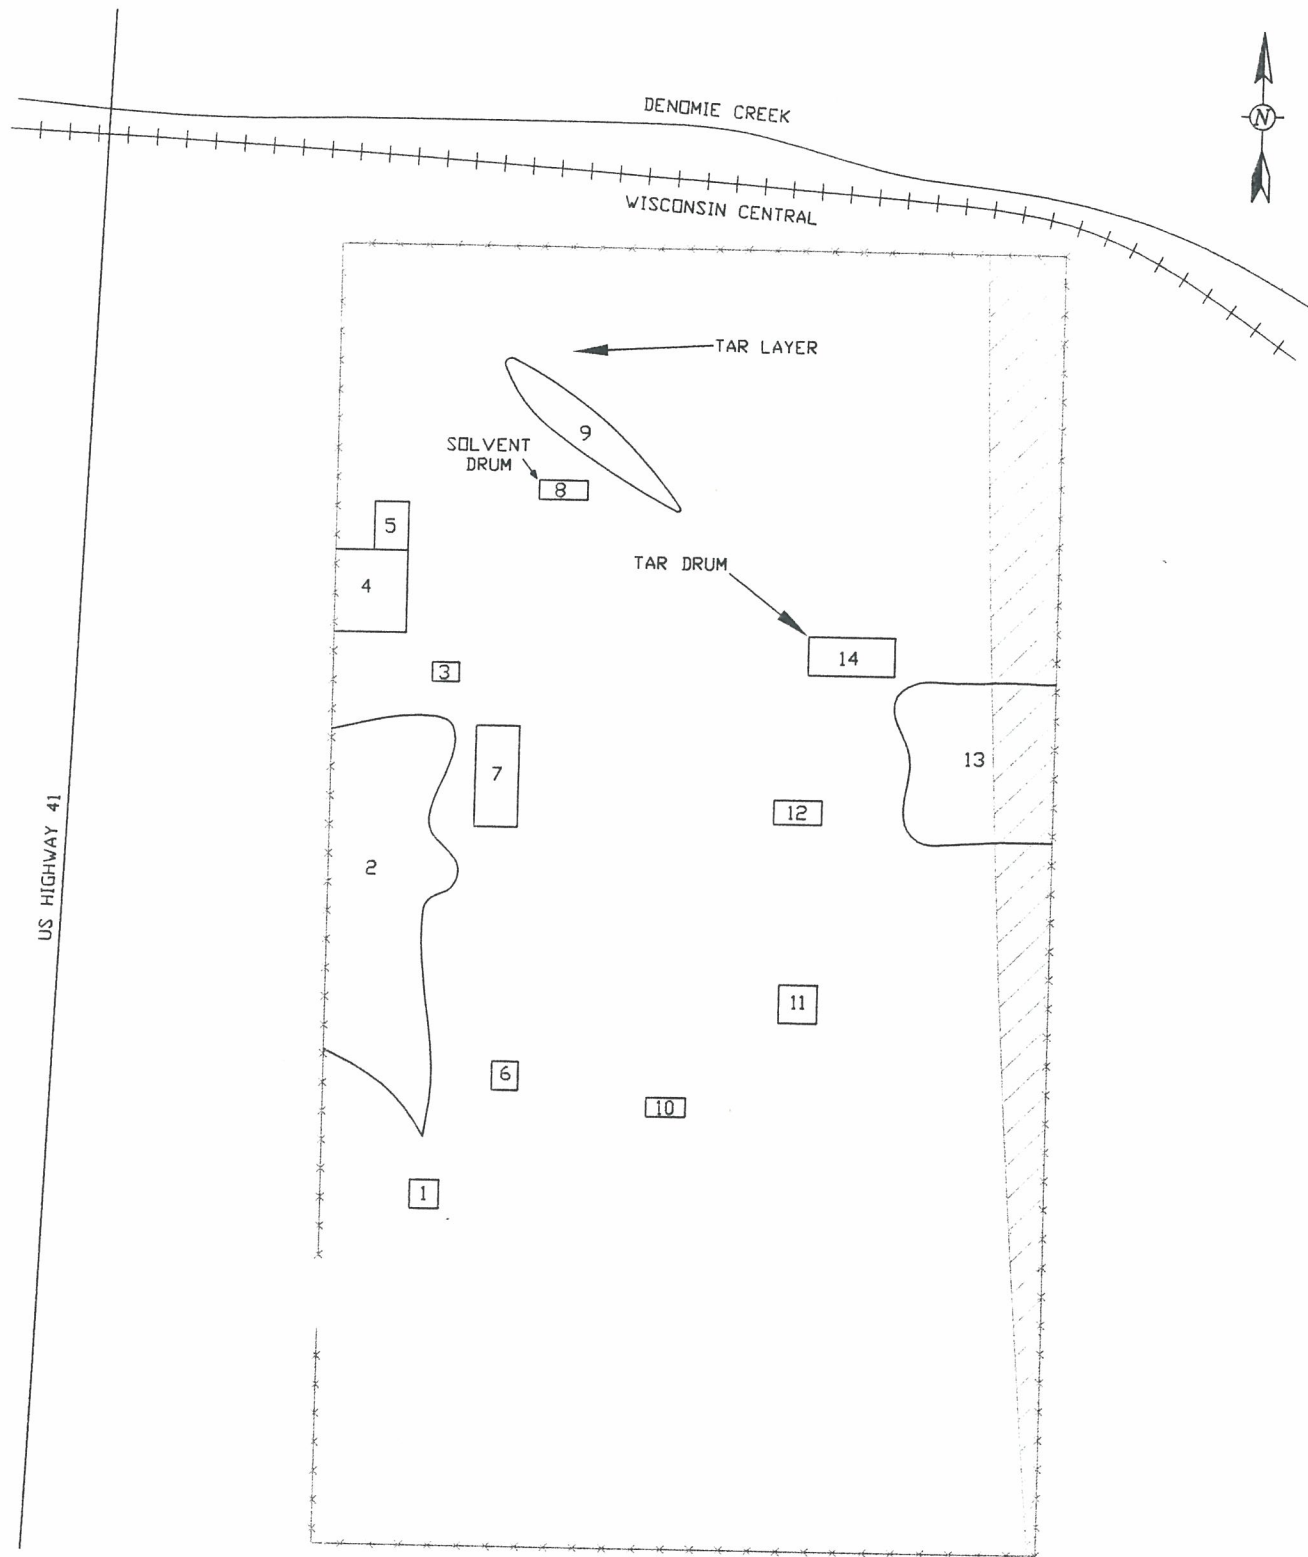
FIGURE 2
SITE LAYOUT MAP

U.S. EPA performed a geophysical survey of the site using a metal detector, magnetometer, and ground-penetrating radar (GPR) unit. The entire site, aside from the extreme eastern edge with the dirt embankment, was swept with the metal detector to search for buried objects, including buried drums. The eastern edge was not swept because it was inaccessible due to the dirt embankment. The metal detector had a subsurface penetration of 10 to 12 feet, the magnetometer had a subsurface penetration of 4 to 6 feet, and the GPR unit had a subsurface penetration of approximately 4 to 6 feet and provided a general image of the source of the anomaly. Once an anomaly was identified, it was outlined for later test pit excavation. A total of 14 subsurface anomalies were identified, all of which were located north of the entrance gate into the site (see Figure 2).

Subsurface anomalies were then further investigated using an MDOT backhoe to excavate the area. Each of the 14 areas was slowly excavated to reveal the source of the anomaly. Items found during the investigation include metal guardrails, metal culvert material, road signs, 55-gallon drum lids, and fence posts. These items were staged on site. Two 55-gallon drums and their contents were also recovered. A deteriorating drum containing a tar-like substance was recovered from Area 14 (see Figure 2). The second drum was recovered from Area 8 (see Figure 2) and was also in poor condition, with multiple holes visible. As the second drum was removed, a strong solvent odor was apparent. START recorded photoionization detector (PID) readings near one of the openings of over 2,000 parts per million (ppm); however, sustained PID readings in the breathing zone of the excavation area were below the action level specified in the health and safety plan for modifying personal protective equipment. A small volume of clear liquid spilled out of the second drum during the excavation, and the impacted soil was sampled (see Section 3.3). Both drums were then staged by MDOT in a lined vessel pending eventual disposal.

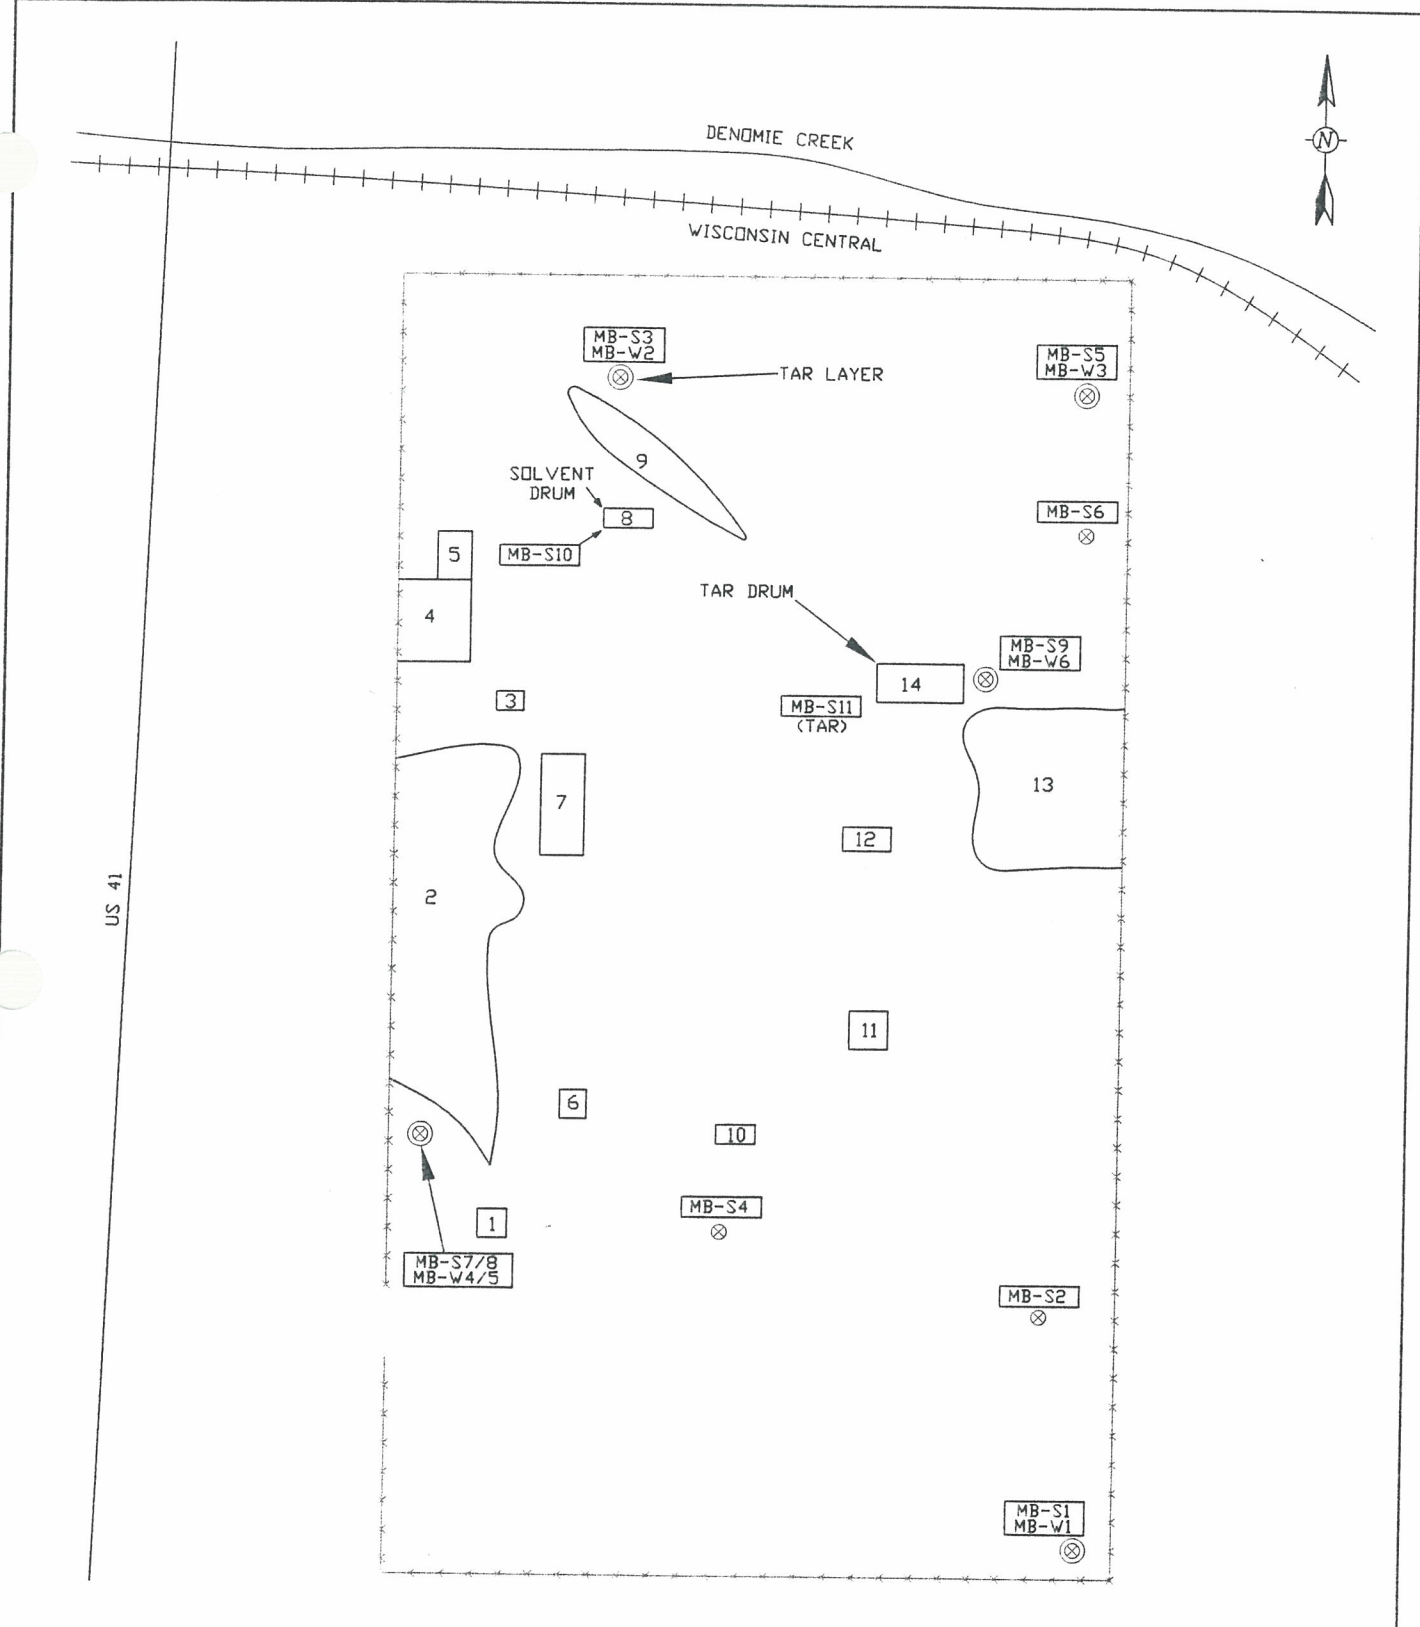
FIGURE 3
SAMPLING LOCATION MAP

A total of eight soil borings were completed using the Geoprobe™ (see Figure 3). Soil boring locations were spaced randomly throughout the site as requested by the U.S. EPA On-Scene Coordinator (OSC). Once the geophysical work was completed, additional locations were chosen based on their proximity to the recovered drums (see Figure 3). The depth of each soil boring was determined based on either the depth to the saturated zone or to Geoprobe™ auger refusal. Subsurface soil and water samples were then collected as discussed below.

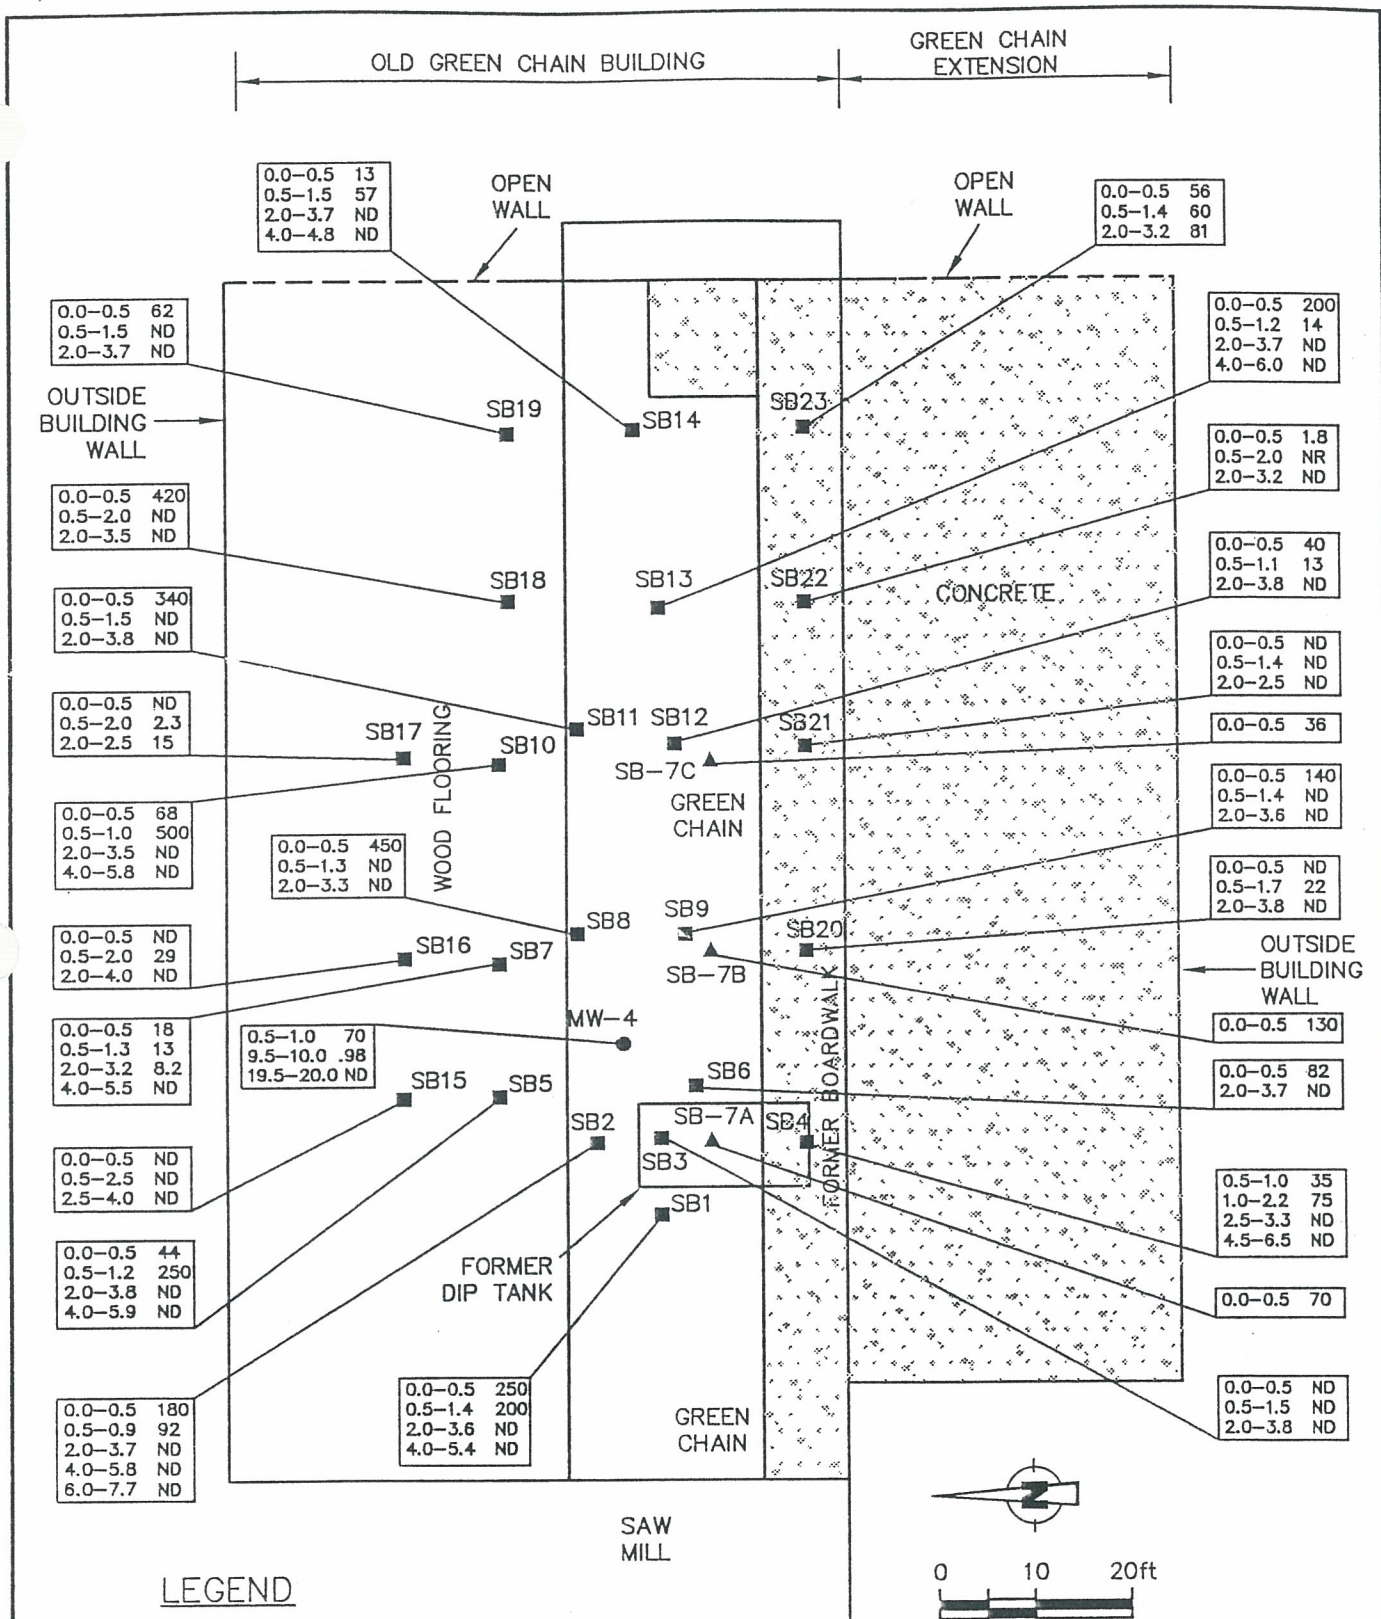
figure 2
AUGUST/SEPTEMBER
SOIL SAMPLING RESULTS
GREEN CHAIN AREA
CONNOR FOREST INDUSTRIES
Baraga, Michigan

These data show that the area and depth of PCP impacted soils beneath the former green chain building have been delineated. In general, PCP impacted soils were observed within the top three feet of an area which includes the open portion beneath the former conveyor and the southern 10 feet of the wood flooring area, extending from the former dip tank to the east wall of the building.
